NAUGATUCK RIVER BASIN
WATERTOWN, CONNECTICUT

LAKE WINNEMAUG DAM
CT 00123

PHASE I INSPECTION REPORT
NATIONAL DAM INSPECTION PROGRAM

MARCH 1980

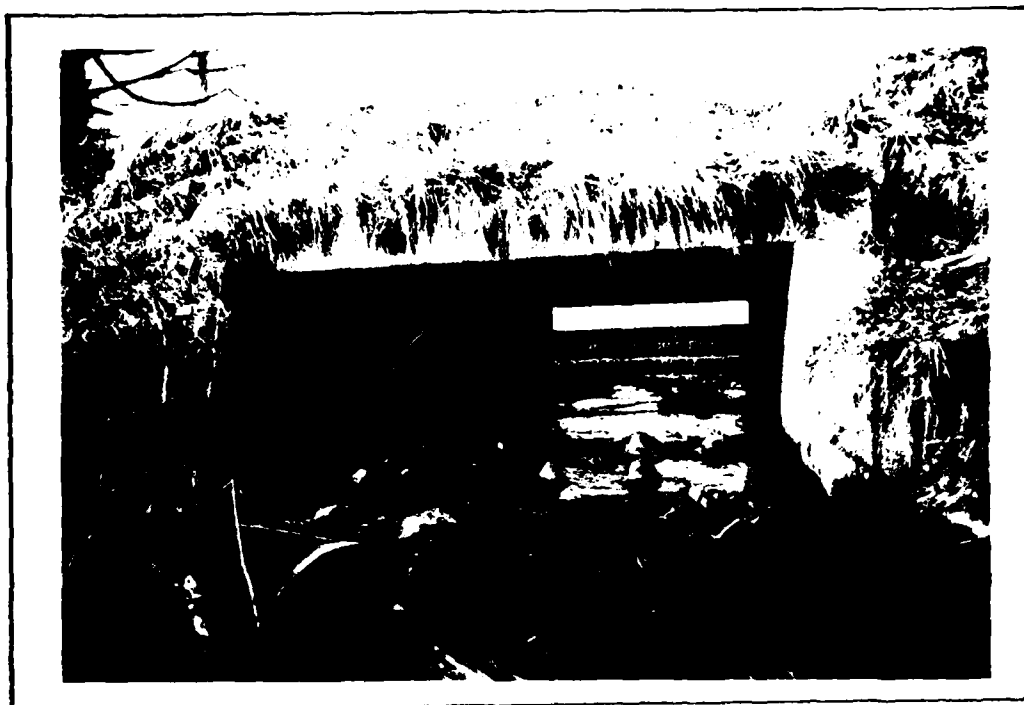
c. Appurtenant Structures. On the date of the inspection, the spillway and the 4-foot wide by 10-foot high culvert which is located under the dam embankment appeared to be in good condition and capable of functioning as designed. Debris consisting of rocks and logs was observed in the culvert.

3. LOOKING UPSTREAM THROUGH THE ROAD CULVERT TOWARDS THE SPILLWAY WEIR. (11/20/79)

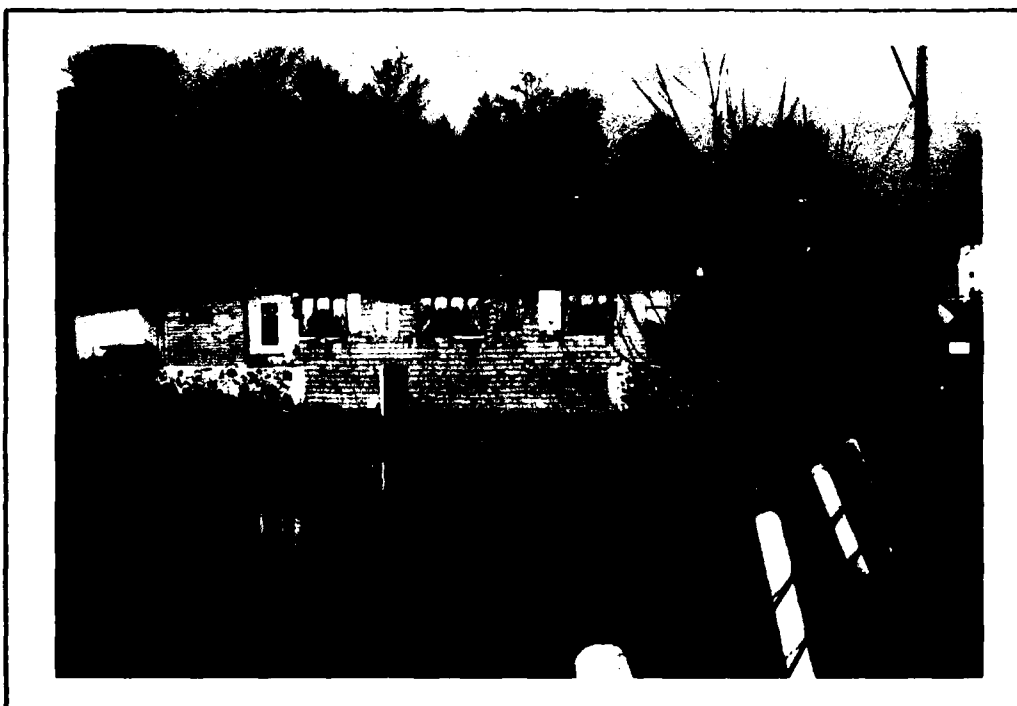
10. BUILDING NEAR THE LEFT ABUTMENT OF THE DAM WITH THE THRESHOLD OF THE DOOR LESS THAN ONE FOOT ABOVE NORMAL POOL. (11/20/79)
